**FINAL SITE MANAGEMENT PLAN FISCAL YEARS 2021 THROUGH 2022 NWS  
YORKTOWN VA**

**Site Management Plan  
Fiscal Years 2021-2022**

Naval Weapons Station Yorktown  
Yorktown, Virginia

Prepared for NAVFAC Mid-Atlantic  
by CH2M HILL, Inc.  
Virginia Beach, Virginia  
Contract N62470-16-D-9000  
CTO WE06

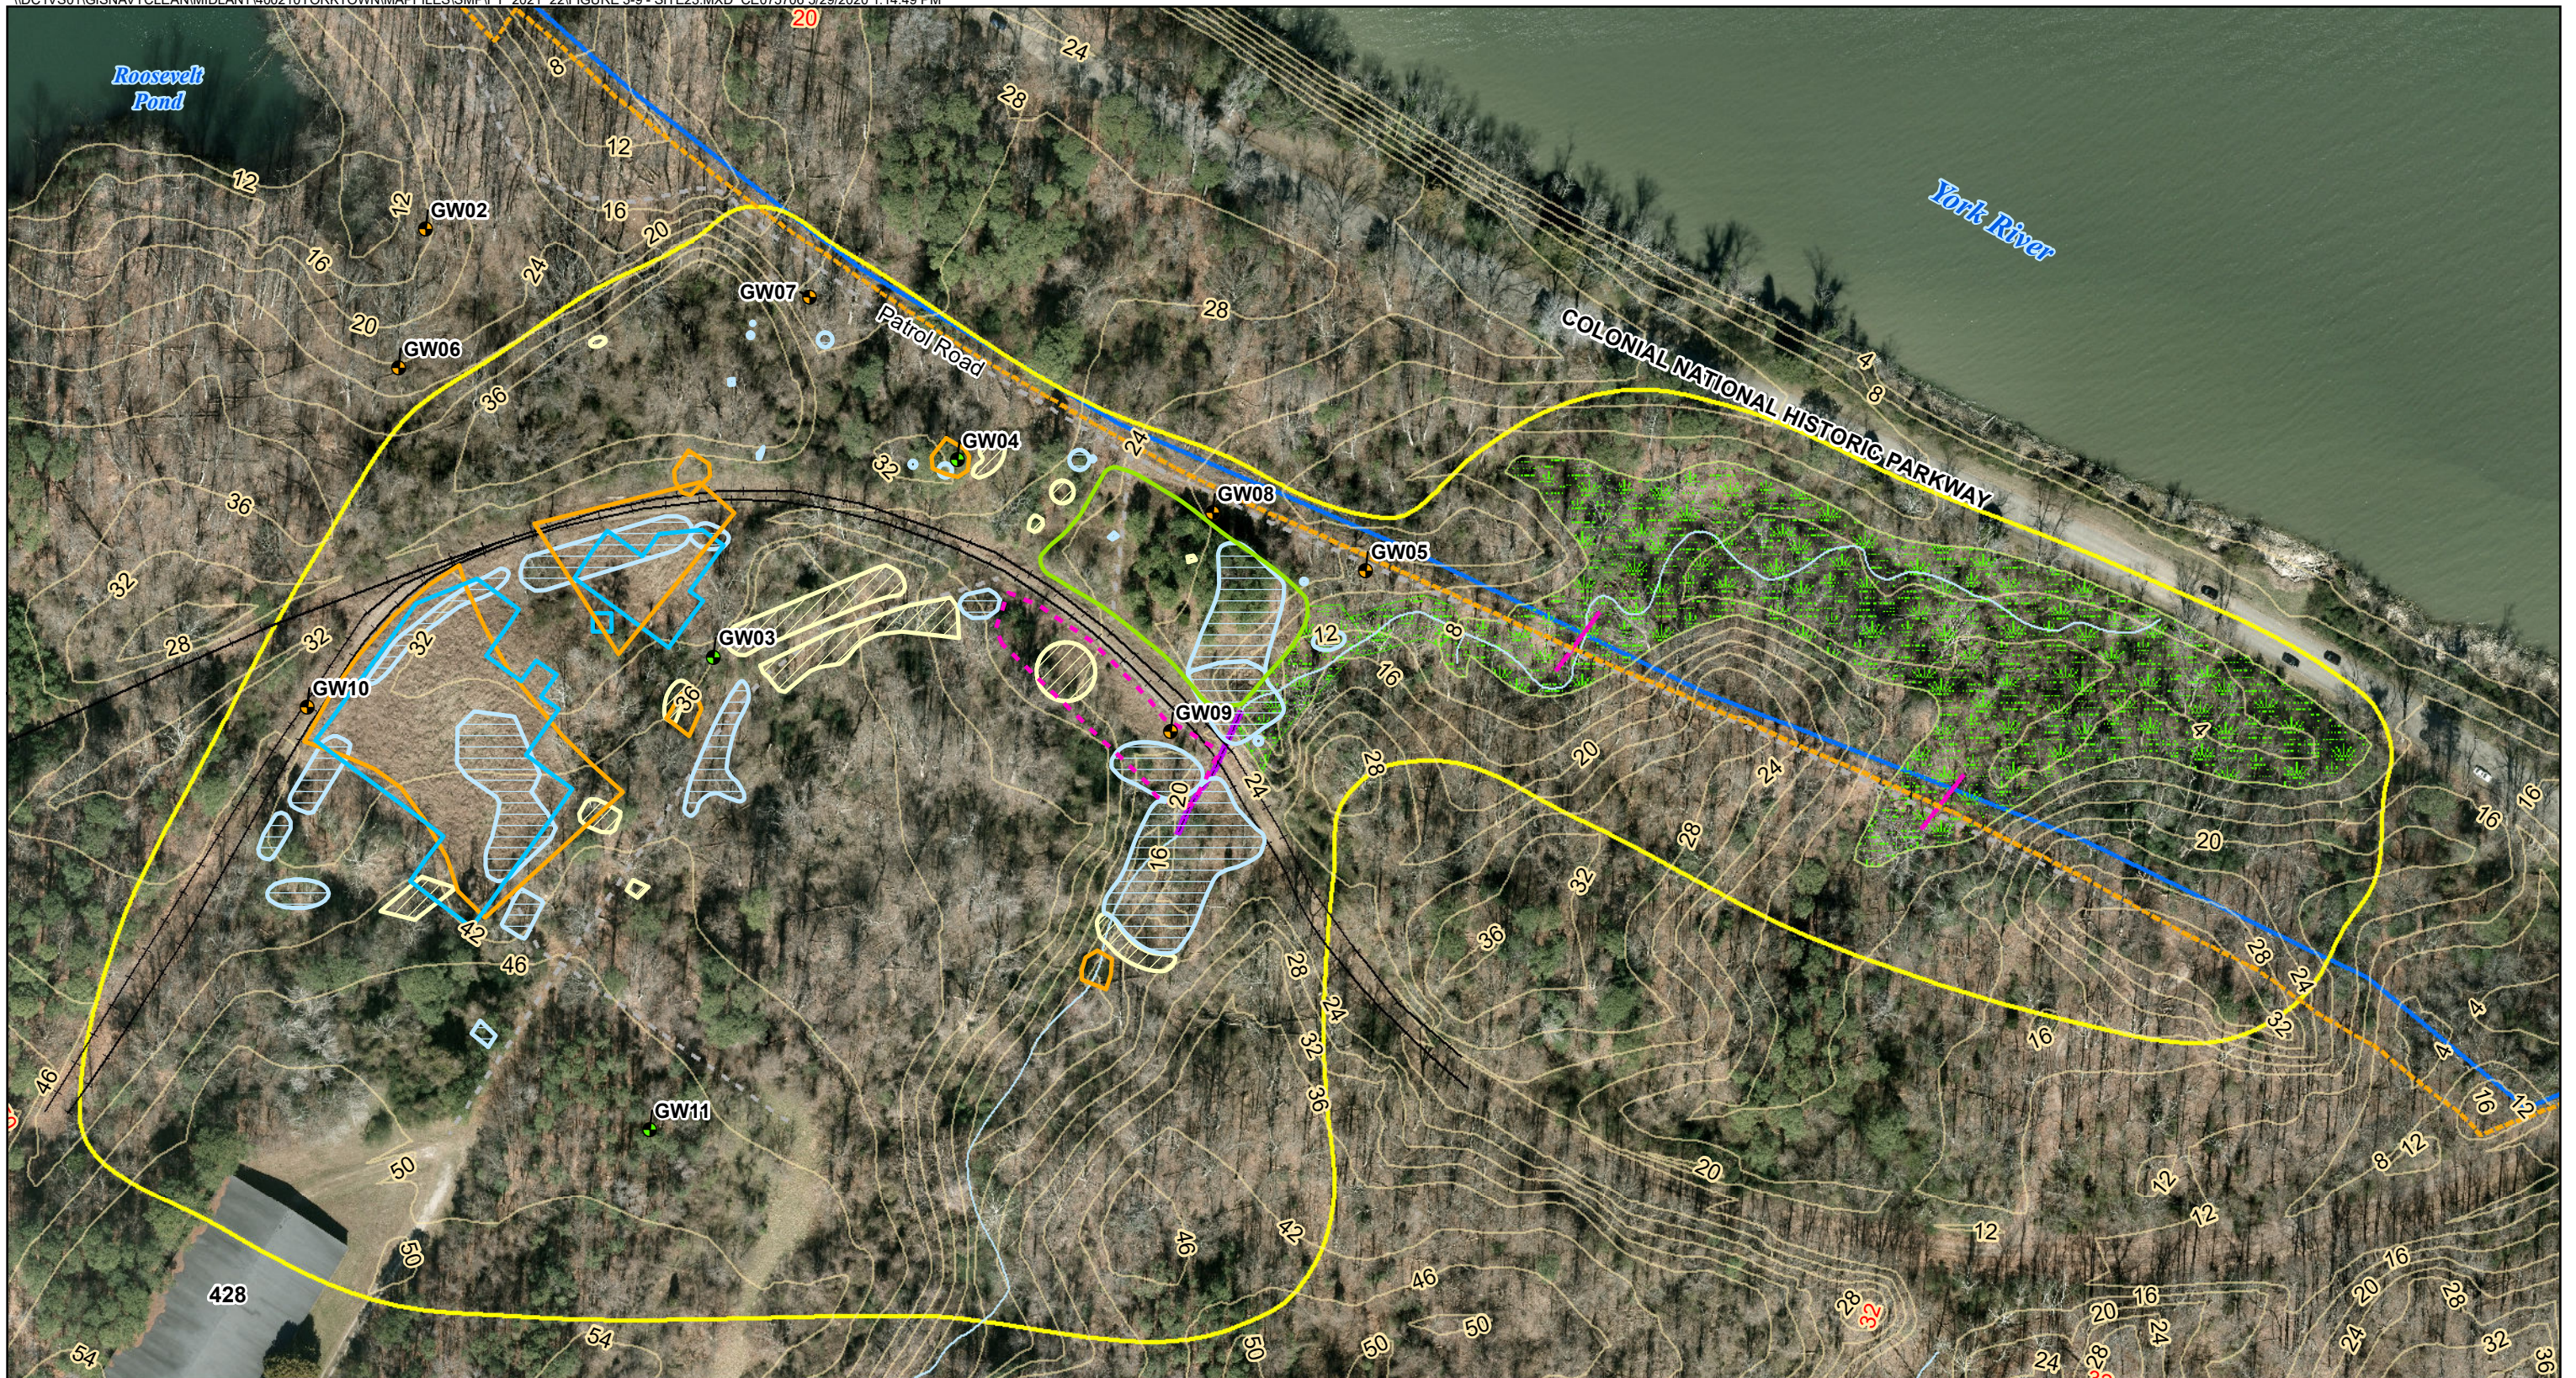
Figure 3-9  
Site 23 - Building 428 Teague Road Disposal Area  
Site Management Plan for FY 2021 to 2022  
NWS Yorktown  
Yorktown, Virginia

- Legend**
- Cornwallis Cave Aquifer Monitoring Well
  - Yorktown-Eastover Aquifer Monitoring Well
  - 2003 (J.A. Jones) Soil Removal Area
  - 1994 (OHM) Surface Debris Removal and Soil/Debris Removal Area
  - 2004 (UNITEC) Soil Removal Area
  - 2009 (Shaw) Soil/Debris Removal Area
  - Former Surface Debris Removal Area Previously Sampled
  - Former Surface Debris Removal Area Not Previously Sampled
  - Fence
  - Former Railroad
  - Unpaved Road
  - 18" Corrugated Metal Pipe
  - Approximate Location of Culvert
  - Surface Water Centerline
  - Elevation Contour (4 ft interval)
  - Study Area (26 Acres)
  - Marsh
  - NWS Yorktown Boundary

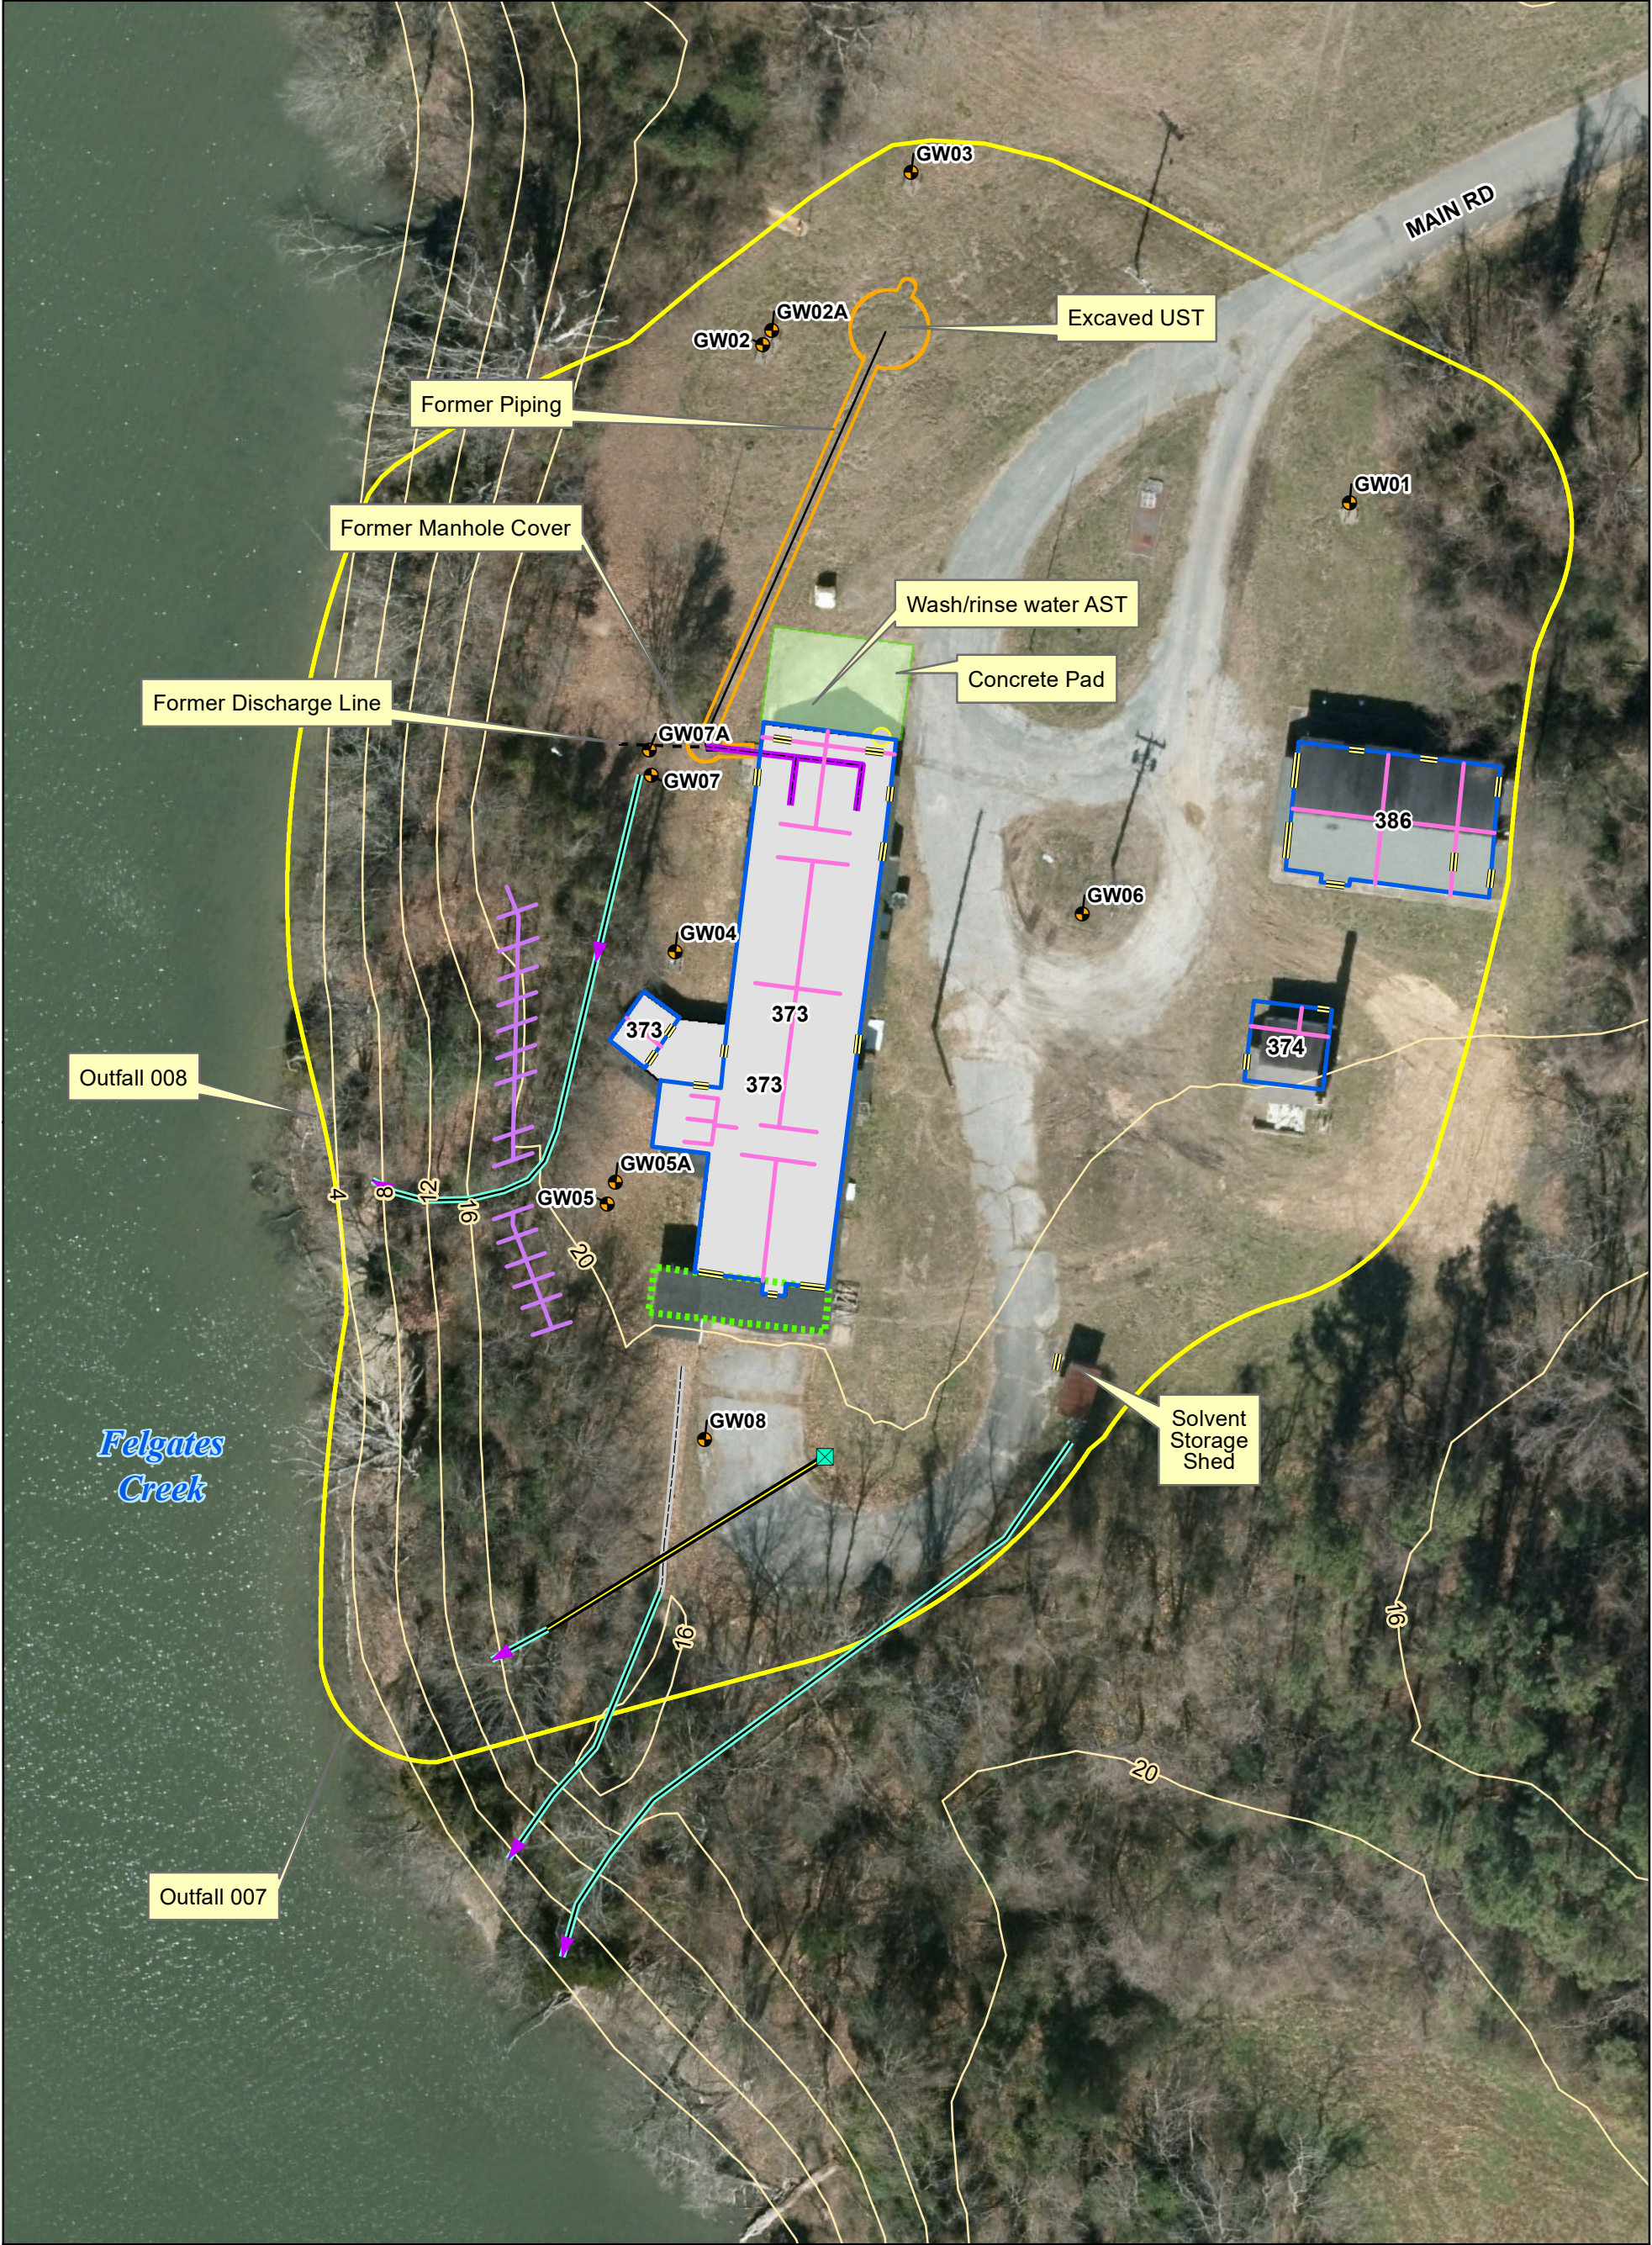
Figure 3-12  
Site 26 - Building 1816 Mark 47 Waste Otto Fuel Tank  
Site Management Plan for FY 2021 to 2022  
NWS Yorktown  
Yorktown, Virginia

- Yorktown-Eastover Aquifer Monitoring Well
- ⊠ Drop Inlet
- Concrete Tank
- Raised Berm
- Door
- Wall
- - Former Discharge Line
